Is Your DB-4060 or DB-4062 duplexer deaf?

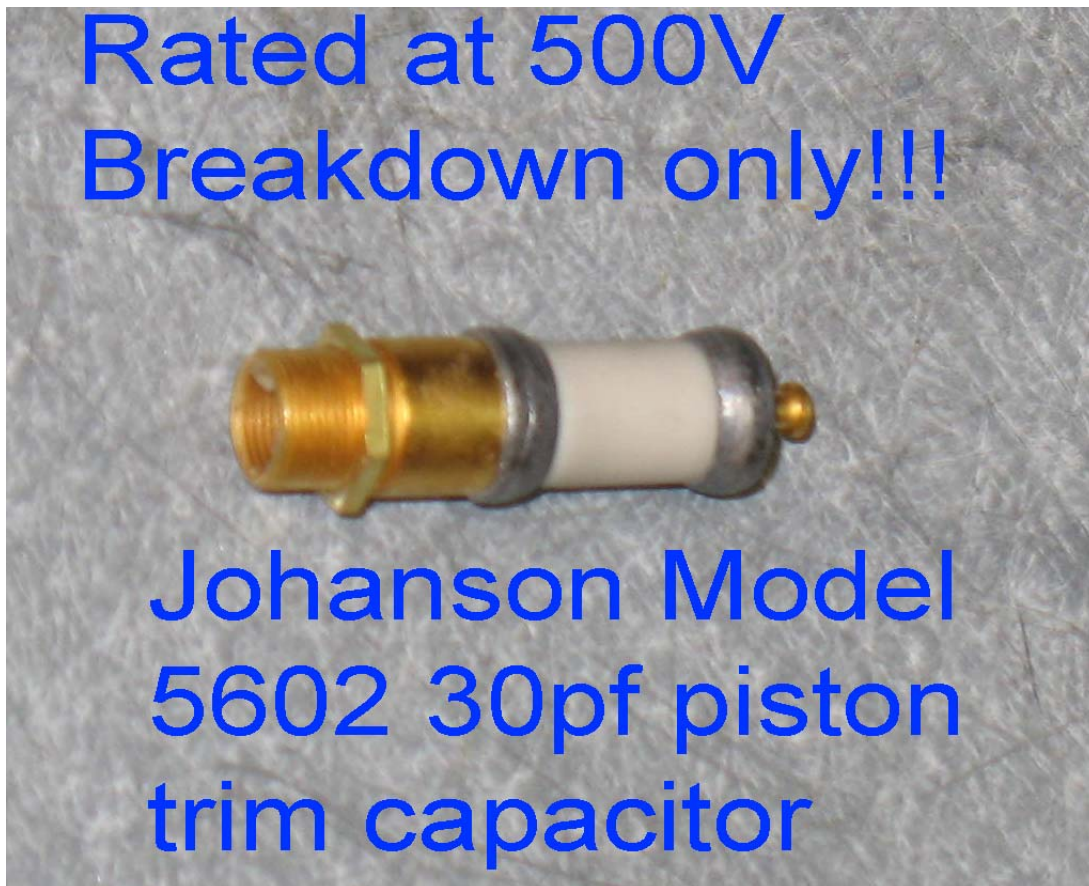
Have you experienced a sudden loss of receiver sensitivity in your repeater? Does it appear to have suffered a sudden case of desense? If you are running a Decibel DB-4060 or 4062 high band duplexer it is very possible the notch tuning has drifted due to failed Johanson 30 pf piston capacitors in the notch tuning assembly. The caps are only rated at 500 volts breakdown. Even with "PolyPhaser" type lightning protection the capacitors can arc over before the lightning protectors fire when a nearby lightning strike occurs.

It turns out the capacitor manufacturer is still in business and I was able to obtain replacements direct from the Johanson Manufacturing . The part number designation is 5602 air capacitor. Cost was 21.44 a piece as of March 2008.

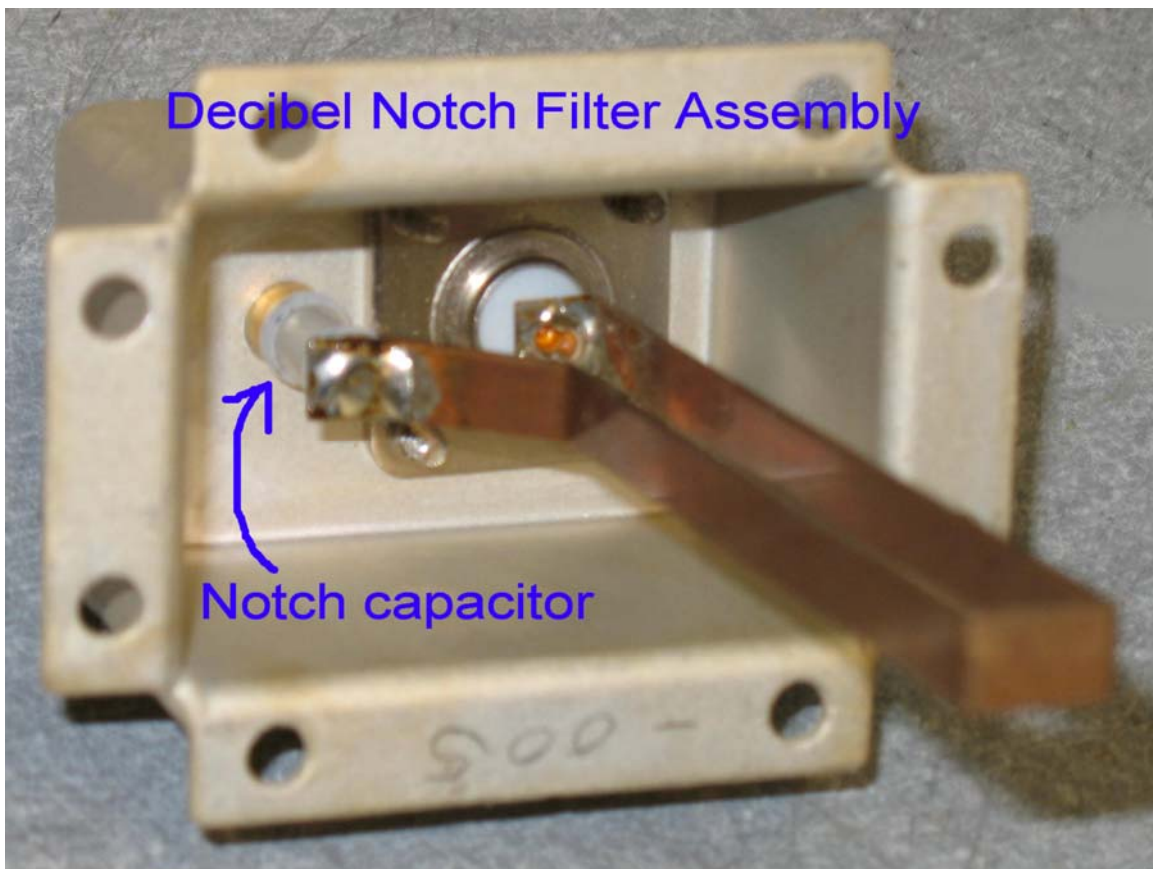
The notch capacitor is located right next the N connector in the shroud mounted on top of the duplexer can. All you have to do is remove the 8 screws holding the shroud and the assembly lifts right out.

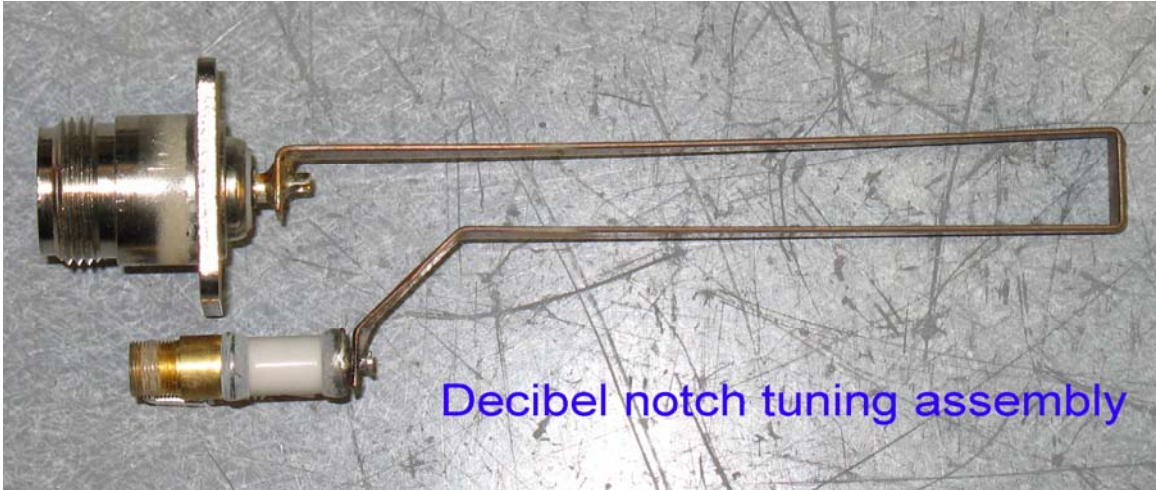
It is easy to unsolder the capacitor with the notch tuning assembly removed.

Unscrew the nut holding the piston capacitor and the four screws hold the N connector in and it will be easy to unsolder the capacitor from the tuned line. See the picture below. I put the new piston cap in the shroud first and then the N connector with the tuned line after that.
