## **Refurbishing The DB-4062 Duplexer**

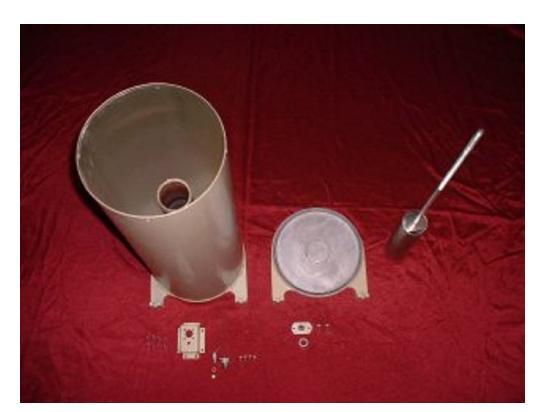
Cavity after disassembly (knob and springs not in photo) Click on photo for larger version

After removing the cable harness and unbolting all the cavities from the top and bottom support rails, the next step was to remove the minibox with the N connector and notch tuning capacitor from the top of each cavity. I then drilled out the four rivets which attach the bottom plate of the cavity. The cavity top plates are welded on and cannot be removed. Next came removal of the tuning rod and plunger from each cavity. The knobs have brass inserts and were soldedered to the rods! I loosend the lock nut on the tuning shaft and turned the knob counter-clockwise until the knob was at least five inches above the top plate of the cavity. With the lock nut re-tightened and the cavity lying on its side, I used a propane torch to heat the rod just below the knob until the solder melted and the knob could be unscrewed from the rod. I immediately tapped the knob sharply on a hard surface to get most of the excess solder out of the hole while it was still molten. I used a paintbrush to quickly brush any molten solder off the tuning rod. The threads inside the knob were then cleaned up using a "square ended" 3/8-24 tap. I cleaned up any solder remaining in the threads of the tuning shaft by running a die onto it. I did this by hand only (not using a handle on the die) in order to be sure I didn't accidentally damage the threads. I then loosened the lock nut, removed the two screws holding the rod lock assembly to the top of the cavity, and unscrewed the entire lock assembly from the rod. With the rod now free and clear, I reached into the open bottom of the cavity, grasped the end of the tuning plunger, and pulled it out the bottom of the cavity (being careful to pull it straight so as not to risk damaging the finger stock). There is a coil spring (actually two springs joined end to end) which runs around the outidse of the finger stock to increase the pressure of the fingers on the moving plunger. Using two angled needle noise pliers I was able to grasp the ends of the springs and unhook them for removal.

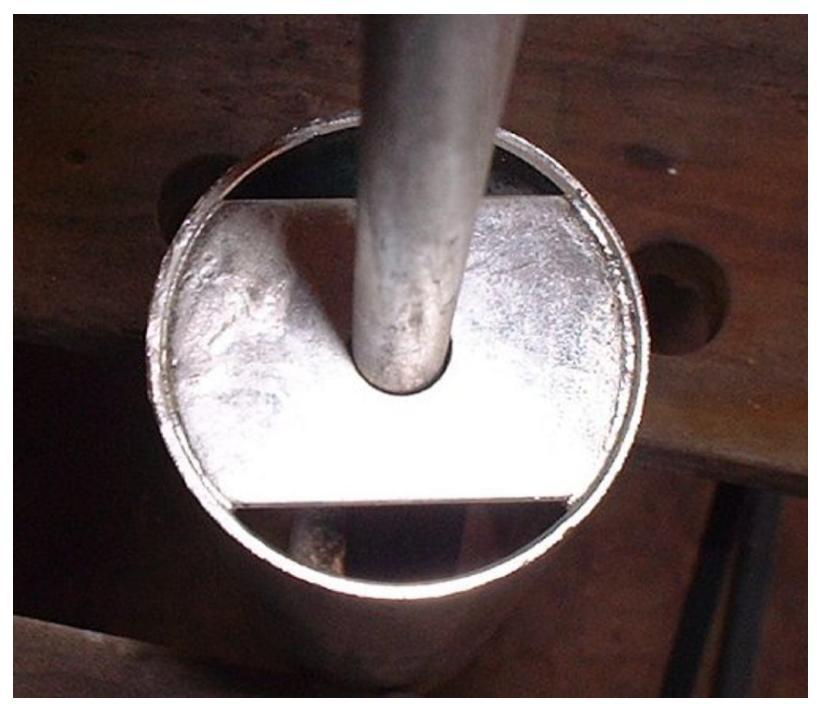
Top of plunger before insertion of teflon sheet around rod

One reason for unstable performance became obvious during disassembly. The plungers had been lightly coated with some (gel?) substance, I guess to provide lubrication? This stuff had deteriorated into a stubborn semi-hard coating on the plungers. [Note: I later learned the product is called Rheolube 362]. It was such that when the cavities were tuned, the fingers tended to ride on top of this 'goo' and not touch the plunger! I found this stuff could be mostly removed, albeit with considerable effort, by using a rag wetted with 99% isopropyl alcohol. Even so it left remnants behind which made the plungers appear dull and feel somewhat rough to the touch. I thoroughly cleaned and polished the plungers using 000 grade synthetic steel wool. I do **not** recommend using regular (metal) steel wool. It took some time to get them shiny and smooth. I also cleaned the threads of the tuning rods with synthetic steel wool. This is even more time consuming if you are like me and unwilling to settle for anything that doesn't appear to be 100% clean. The finger stock and the springs that go around it were also thoroughly cleaned using a rag soaked in isopropyl alcohol followed by a lot of gentle buffing with the synthetic steel wool.

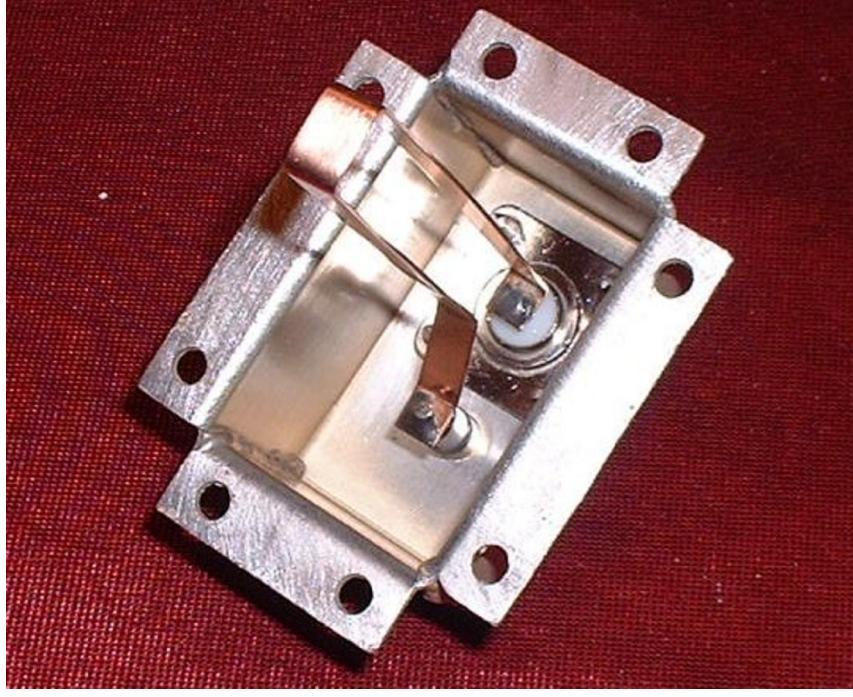
A refurbished loop and connector assembly

Next I removed the tuning loop, N connector, capacitor assembly from the minibox. All mating metal surfaces were thoroughly cleaned up

using small strips of 360 grit sanding sponge. This includes the flanges of the minibox where it touches the top of the cavity and the inside of the minibox where the N connector and capacitor touch it. I also cleaned the top of the cavity where the minibox makes contact with it and where the rod locking assembly attaches to the cavity top. The bottom of the lock plate assembly was cleaned as well.

Although perhaps not necessary I also cleaned the loops themselves. They were stained and ugly from solder flux that had not been cleaned off after manufacture. Some considerable time and care with small strips of 360 grit sanding sponge resulted in loops that were smooth and shiny. I then rubbed them with Nevr-Dull wadding metal polish and removed any visible residue from this process with a paper towel. I was very careful not to touch the loops with my fingers during or after this process. Again this is probably overkill but if I am going to refurbish something I'm gonig to get it as good as I can.
