And Another Pyramid, Phase III model PS-25

Having gotten some good feedback from folks reading my website, I have decided to add my experiences with another high current low voltage supply commonly used with modern transceivers, this time a Pyramid Phase III PS-25 that has variable voltage output and is capable of 25 amps current.

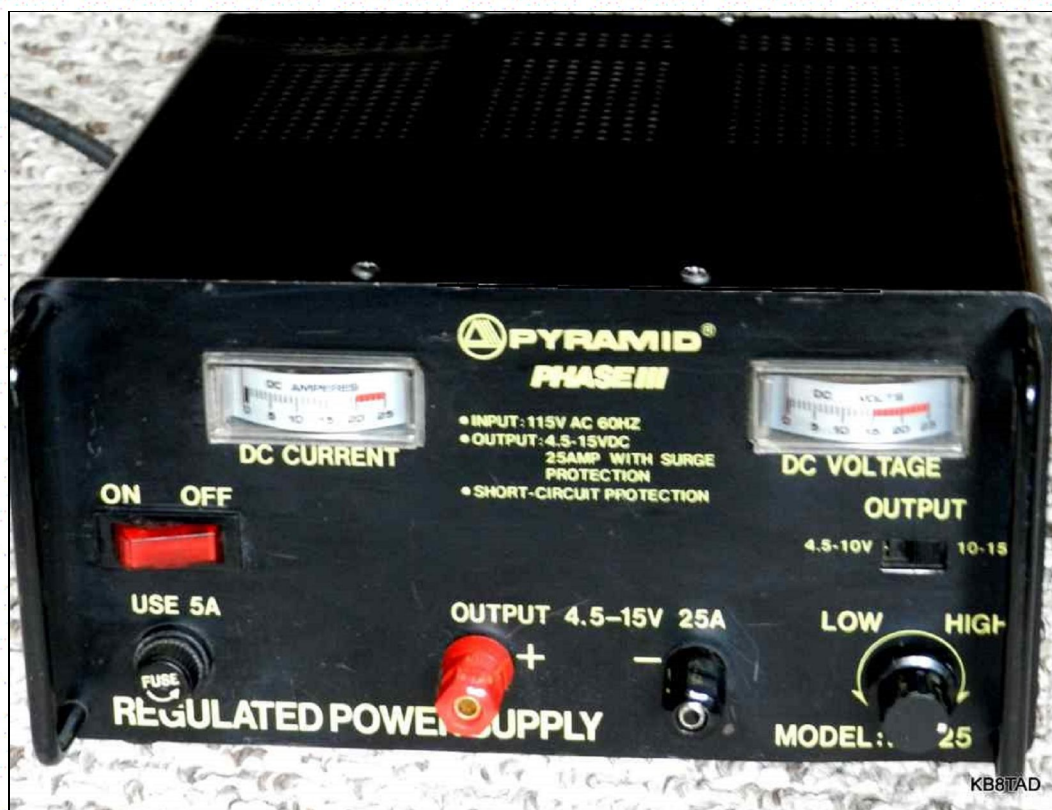
Note that the 25 amp rating is definitely not for continuous use. Like the [previous Pyramid PS-21KX](#) and all such linear power supplies, this one is heavy with the large transformer inside. The unit has both an ammeter and a voltmeter. The supply is designed to be controlled by the front panel "low-high" control for variable voltage output with two selectable ranges of 4.5 to 10 volts and 10 to 15 volts via the slide switch marked "output". Unlike the Pyramid PS-21KX, this one has an adjustable crowbar circuit on a separate board.

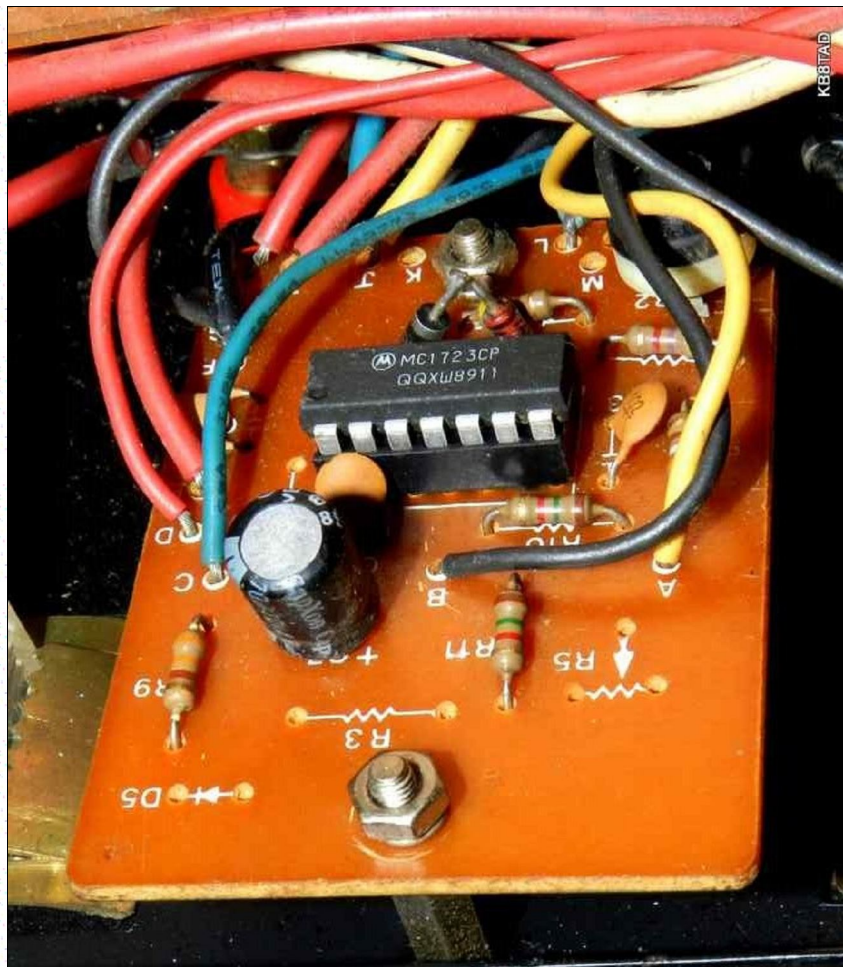
The heart of this power supply like most ham radio linear power supplies, is the little LM-723 regulator. See the [previous Pyramid PS-21KX repair](#) for more information on the LM-723. The one in the PS-25 is socketed, allowing easy replacement of this very inexpensive 14 pin chip.

The LM-723 board in the Pyramid PS-25.

The LM-723 is a complete voltage regulator all by itself. Its voltage output (pin reference 10) provides a maximum current of 150 mA which is then fed to the base of a 2N3055 NPN transistor (inside the case). Think of that one 2N3055 as a simple current amplifier. The voltage at its base determines the voltage at its emitter. The emitter of the 2N3055 inside the case feeds the bases of four more 2N3055 NPN pass transistors which are wired in parallel. Think of those four pass transistors as a bigger current amplifier. The voltage at the bases of the four pass transistors determines the voltage at the emitters which provide the output of the power supply. The collectors for all the 2N3055 transistors are fed by unregulated DC from the combination of the power transformer, a heavy duty diode bridge and capacitor filter bank (five 4700 uF caps in parallel).

The unregulated power of this Pyramid was in good condition as was the fuse. I found a dead LM-723 chip. All five of the 2N3055 transistors were in good condition. Replacing the LM-723 chip was all the repair that was needed. I cleaned the on-board pots and the front panel voltage control with contact cleaner and then also added a MOV across the power line after the fuse and power switch since I suspected that a spike on the power line had caused the LM-723 to fail. An alternate solution is to simply plug the Pyramid into a late-model UL and CSA approved surge protector which has the MOVs included. (Late model surge protectors use fused MOVs in case of catastrophic breakdown in the MOVs themselves.) A load test with several car headlights verified a fully functional power supply.

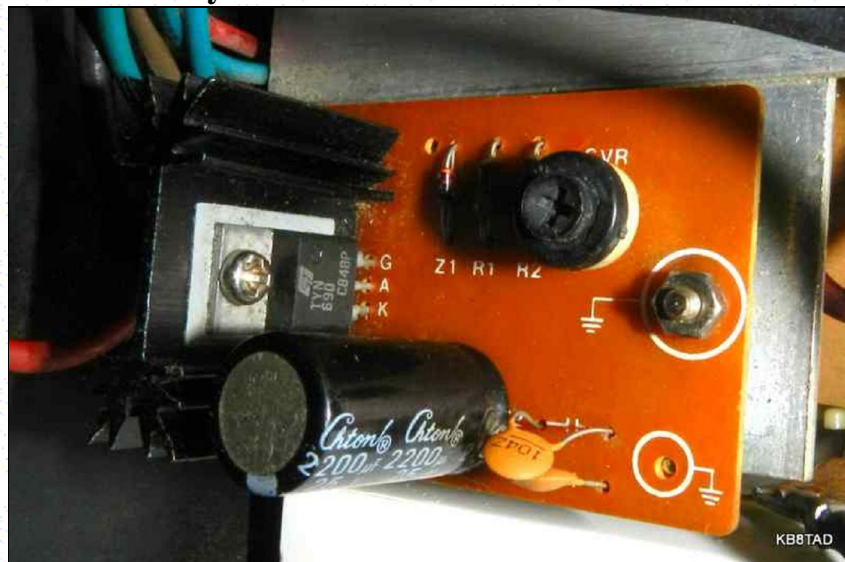
The little crowbar circuit board in the Pyramid has a heavy red wire that goes directly to the positive output terminal.

The Crowbar board in the Pyramid PS-25. The SCR is a TYN-690. Note the heat sink.

Rather than unsoldering that wire, I opted to simply cut it in a convenient location. I wanted to be sure the crowbar was working and set to trigger at a known selected voltage. I had earlier cleaned the on-board voltage control. I connected a car headlight in between the cut parts of the wire and then adjusted the control on the crowbar board until the SCR fired and the headlight lit up. The circuit was working properly. Powering the supply down and then back up to reset the SCR, I used my digital meter to set the trigger point at just a bit over 15 volts, about 15.4. Testing again with the lamp load for the SCR proved the triggering was working as expected at that voltage. I believe that the factory set point was about 16 volts.

I later spliced the cut wire with a wire nut making it easier to open the circuit and test again in the future.
