MSF5000 DIGITAL ERROR CODES

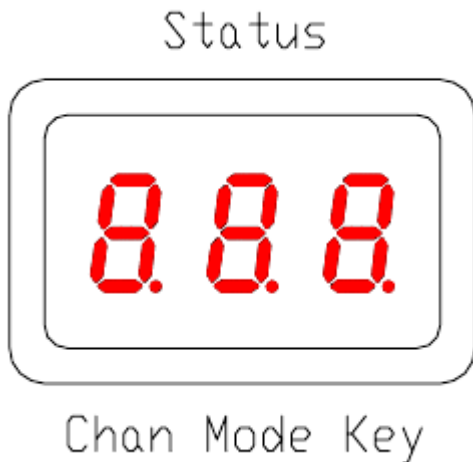
There are five different categories of error codes. The category is displayed in the left-most digit of the Status display. The type of error is represented in hexadecimal format in the two right-most digits of the Status display. Hexadecimal coding permits up to 256 possible error codes per category.

The figure below illustrates the error code format and how it is presented within the Status display.

The “Chan” digit displays the type of error:

- A = AUDIO ERROR
- d = DIGITAL ERROR
- E = OPERATIONAL ERROR
- o = TEST MODE ERROR
- U = UNDEFINED ERROR

The “Mode” and “Key” digits display the error code. Refer to the following tables for specific error code definitions.

When the station detects an error, an error code appears in the Status display. This code is used to aid in the troubleshooting of the MSF5000. Error codes are differentiated from other MSF codes by illuminating all three decimal points of the Status display.
