FLEXIBLE
STATIONMASTER

M-31726-A

Q & A for Phelps-Dodge Flexible Stationmaster VHF Antenna

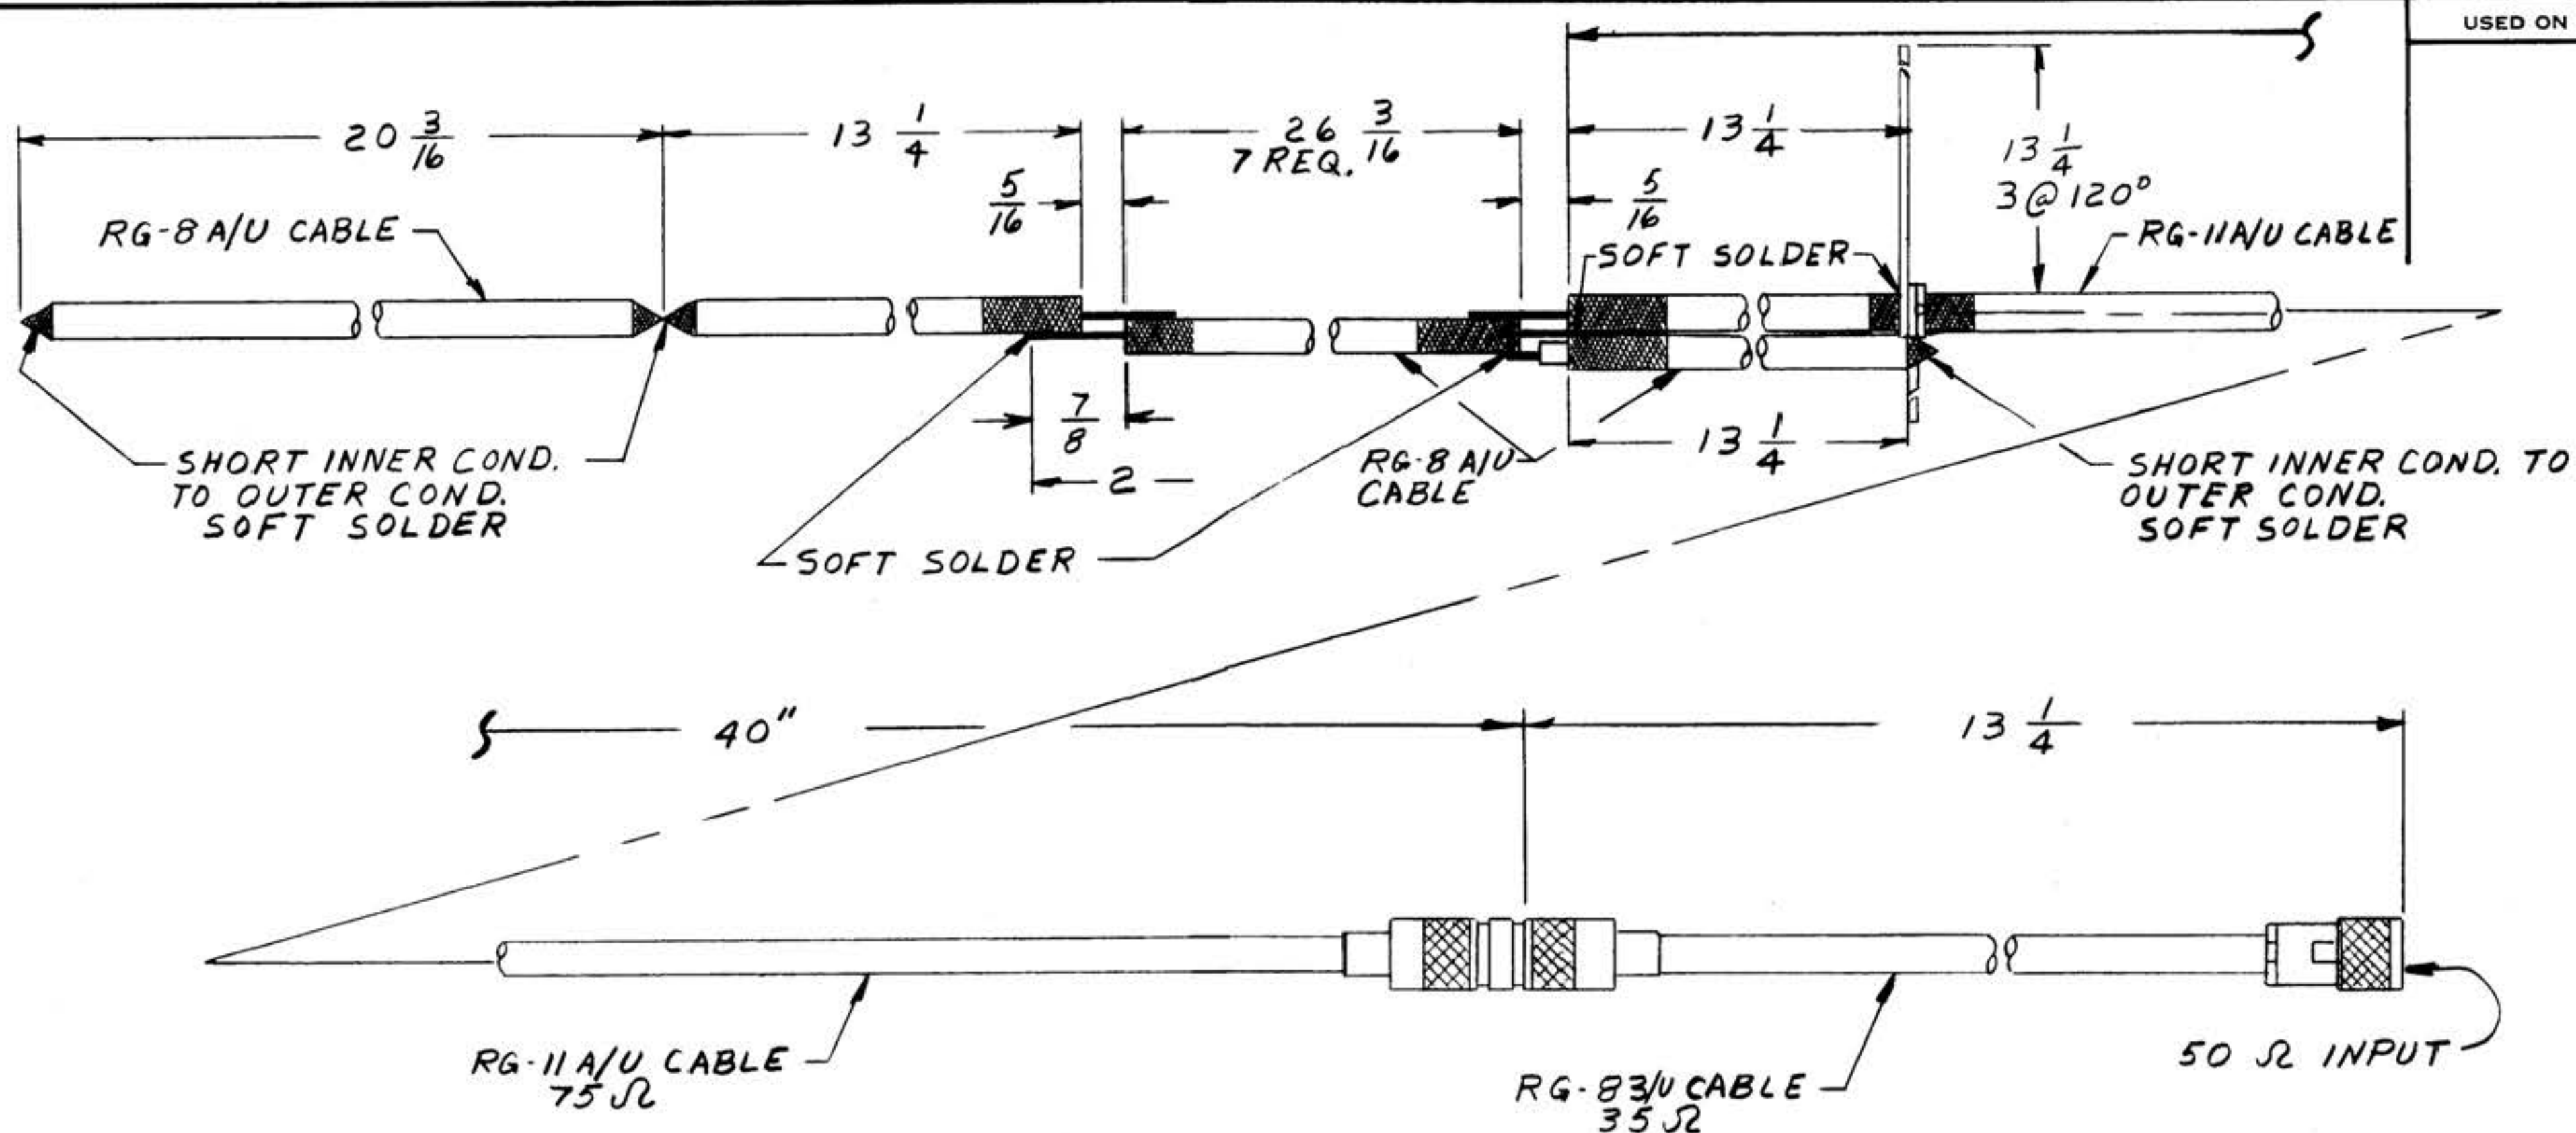
Along the top of the drawing, near the middle, there's a 26-3/16 inch section that says "7 REQ.". This means there are seven such alternating pieces of RG-8A/U, all wired in series. Yes, that's over 15 feet of length. There must always be an odd number of sections at this location.

Further to the right there are two pieces of RG-8A/U coax in parallel, both 13-1/4 inches long. These make a tuned shorting stub, a filter if you could call it that.

At the far right of the drawing, where the piece of RG-11A/U begins, there's the notation of "13-1/4 3 @ 120°" above it. This refers to three metal rods 13-1/4 inches long, equally spaced, used as ground radials that stick out perpendicular to the antenna.

The diagram mentions "soft solder". This is just standard 60/40 tin/lead solder. When Clint built his, he wrapped a small diameter bare copper wire around each joint several times then soldered them well.

The whole antenna is over 22 feet long and can be placed inside a 2 inch PVC pipe.

Stationmaster antennas built in the 1970s often broke at their internal solder joints, even when encased in a fiberglass tube. They do not like to be bent. People have successfully removed the guts of these antennas and repaired the broken joints to get them going again.
